**EXPANDED PRE-CERCLIS SCREENING
SIXTY MINUTE CLEANERS
ROCK HILL, SOUTH CAROLINA
YORK COUNTY
SCS# 123 457 884**

May 7, 2019

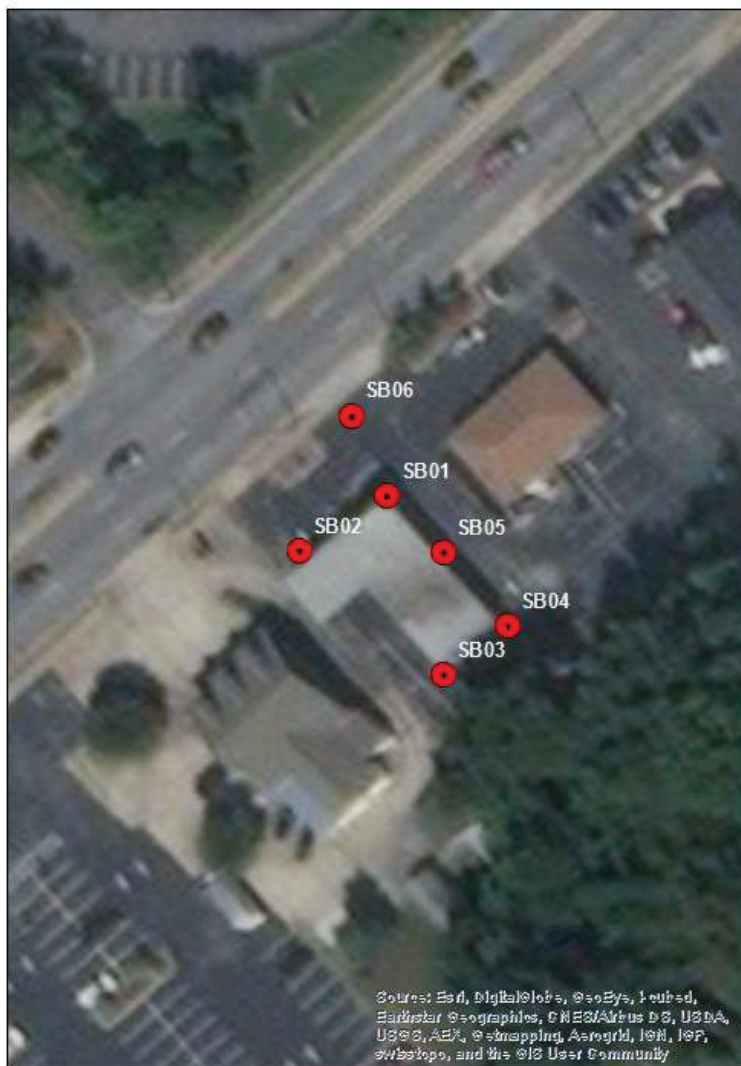
Figure 8
Soil Sampling Location Map
Sixty Minute Cleaners
Rock Hill, SC

As part of the January 2014 field investigation, six soil borings were conducted and 18 soil samples were collected and screened for chlorinated solvents using the Color-Tec screening method (Reference #11). Splits of two soil samples (SB01-2 and SB06-4) were also analyzed for

VOCs using USEPA method 8260B. Figure 8 depicts the location of those samples and Table 3 below summarizes the results.

As shown in Table 1, all samples collected at soil boring location SB01 as well as soil sample SB03-8 exhibited positive Color-Tec CVOH screening values ranging from 0.2 to 30 Color-Tec Units (CTUs). PCE was detected in soil boring SB01-2 at a laboratory concentration of 29,300 µg/kg, exceeding the USEPA soil screening level (SSL) of 2.3 µg/kg for leachability to groundwater and the residential direct exposure level of 8,100 µg/kg for PCE. In addition, TCE was detected in SB01-2 at a laboratory concentration of 1,530 µg/kg, exceeding the USEPA SSL of 1.8 µg/kg for leachability to groundwater and residential direct exposure level of 410 µg/kg for TCE. Furthermore, cis-1,2-DCE was detected in soil sample SB01-2 at a laboratory concentration of 7,490 µg/kg, exceeding the USEPA SSL of 21 µg/kg for leachability to groundwater for cis-1,2-DCE. Trans-1,2-DCE was also detected in soil sample SB01-2 at a laboratory concentration of 33 µg/kg, exceeding the USEPA SSL for leachability to groundwater of 29 µg/kg for trans-1,2-DCE. Finally, vinyl chloride was detected in soil sample SB01-2 at a laboratory concentration of 813 µg/kg, exceeding the USEPA SSL of 0.69 µg/kg and residential direct exposure level of 59 µg/kg for vinyl chloride (Reference #7, Reference #12).

Soil sample SB06-4 contained cis-1,2-DCE at a laboratory concentration of 6.09 µg/kg, below the USEPA Region 9 SSL of 21 µg/kg for cis-1,2-DCE. In addition, SB06-4 contained vinyl chloride at a laboratory concentration of 9.05 µg/kg, exceeding the USEPA SSL of 0.69 µg/kg for vinyl chloride (Reference #7) (Reference #12).

Based on the soil sample Color-Tec CVOH screening results and laboratory analytical results, drycleaning-related soil contamination at levels exceeding USEPA screening values are present on the Sixty Minute Cleaners facility adjacent to the building to a depth of at least 2 feet BGS and likely extends to a depth of at least four feet BGS (Reference #7). However, the extent of the soil contamination appears to be limited in scope and confined to the Sixty Minute Cleaners property.
